### **Carter Brothers Standard Gauge Rolling Stock**

#### John F. Hall, SPC Historian

#### **PROGRESS SINCE THE LAST NEWSLETTER**

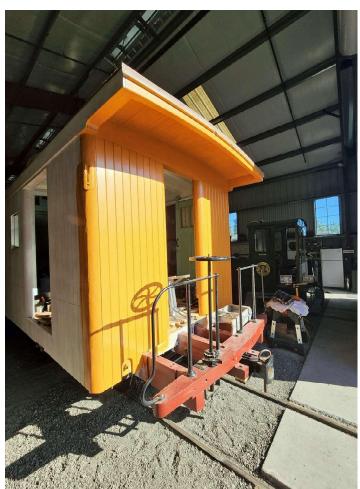
A end of NWP caboose 6101 showing color in the shade. 4 coats on end and first coat on left. Photo - AJL Cary

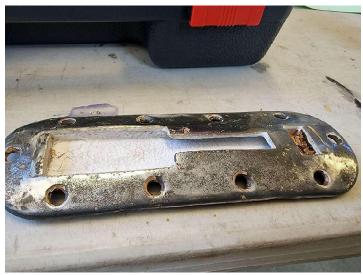
Signal lamp bracket front.

The brackets were taken down and cleaned, leading to a surprise. Two of the brackets are ungalvanized and are stamped N.W.P. R.R No. 2. The others are newer welded and galvanized brackets. Inside the older brackets was some 'yellow' paint (and orange and even some mineral red). Another surprise was that these brackets had always been painted the same color as the car body—not black like SP 1010.

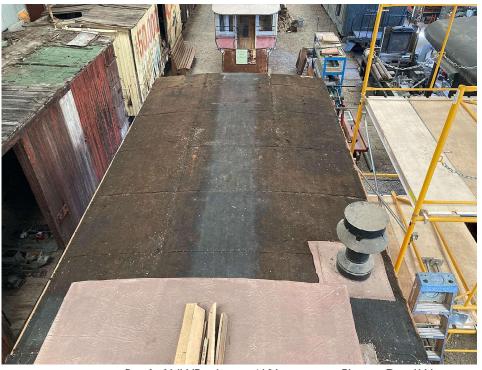
Roof of NWP caboose 6101.

**6/27** (Mon) - Volunteers: D. Waterman (6 hrs); J. Stutz (6 hrs). Today David worked on stripping the old canvas roofing material off of NWP caboose 6101. We will likely reuse the felt under the canvas as it is still in good shape and just some minor repair will be needed. John worked on some ongoing grounds maintenance.

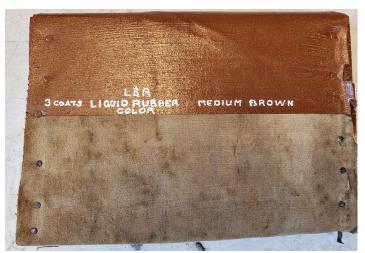
Liquid Rubber test.

The rot was reinforced with penetrating epoxy and will need some PC-Woody epoxy filling. In addition, the L&R Liquid Rubber Color sample arrived and 3 coats were applied by brushing onto half the "test roof." Results are very good. This product is "Medium Brown" which is a tad more "chocolate" than the mineral red on the existing window sashes (it can apparently be tinted). Accomplishments: removed signal lamp brackets; cleaned and polished signal lamp brackets; brushed one side of the with the first coat of finish coat, making sure to fill the cracks between boards; painted one-half of the test roof with medium brown liquid rubber; purchased additional sanding sponges, pneumatic 16 ga finish nail gun (drive 1"-2-1/2 finish nails), finish nail sticks, and 4-1/2" grinder sandpaper flappers. Removed outside door handles on baggage room doors.

It is looking like the canvas roof will be sealed using LR color coat in Medium Brown. The Semcoat is also promising but is slightly more expensive and its brown color is too dark. Both of these coatings have the advantage of very easy repair.

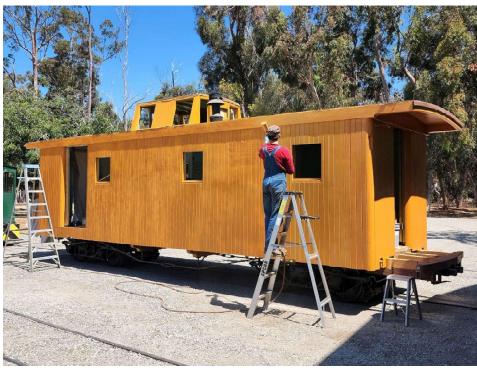
David Waterman sprays finish coat

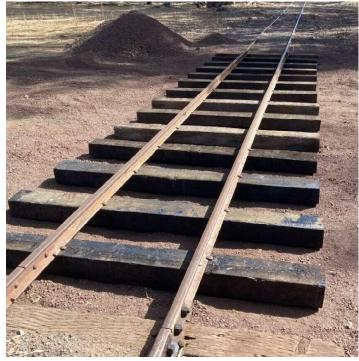
First the rail was removed and the bad ties dug out. Next the new ties we laid out and the rail was replaced. Photo - David Waterman

**6/7-8** (Tues/Wed) - Volunteer: D. Waterman (16 hrs). A section of our old mainline that was buried in ballast was found to have a number of ties needing change out and some spiking issues.

Since the area also had square joints, the plan was to lift the rails and install 15 new ties in the section.

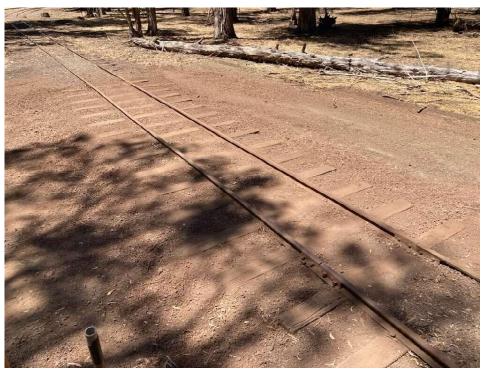
The completed ties replacement.

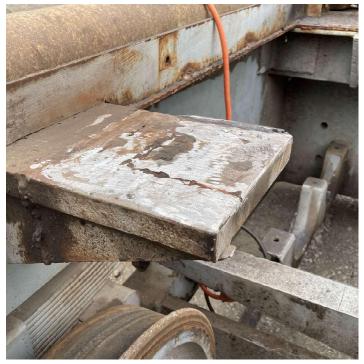
New engine mount in the Whitcomb. Photo - David Waterman

**9/26** (Mon) – Volunteers: Bruce Sorel, D. Waterman (8 hrs). Today we worked on the Whitcomb and finished installing the motor mounts, which involved using the tractor to place and remove the engine and welding a new front mount onto the frame.
