Preliminary Restoration Analysis
of
Northwestern Pacific Railroad Caboose No. 6101

SPCRR, The Railroad Museum at Ardenwood
Kevin V. Bunker, Curator

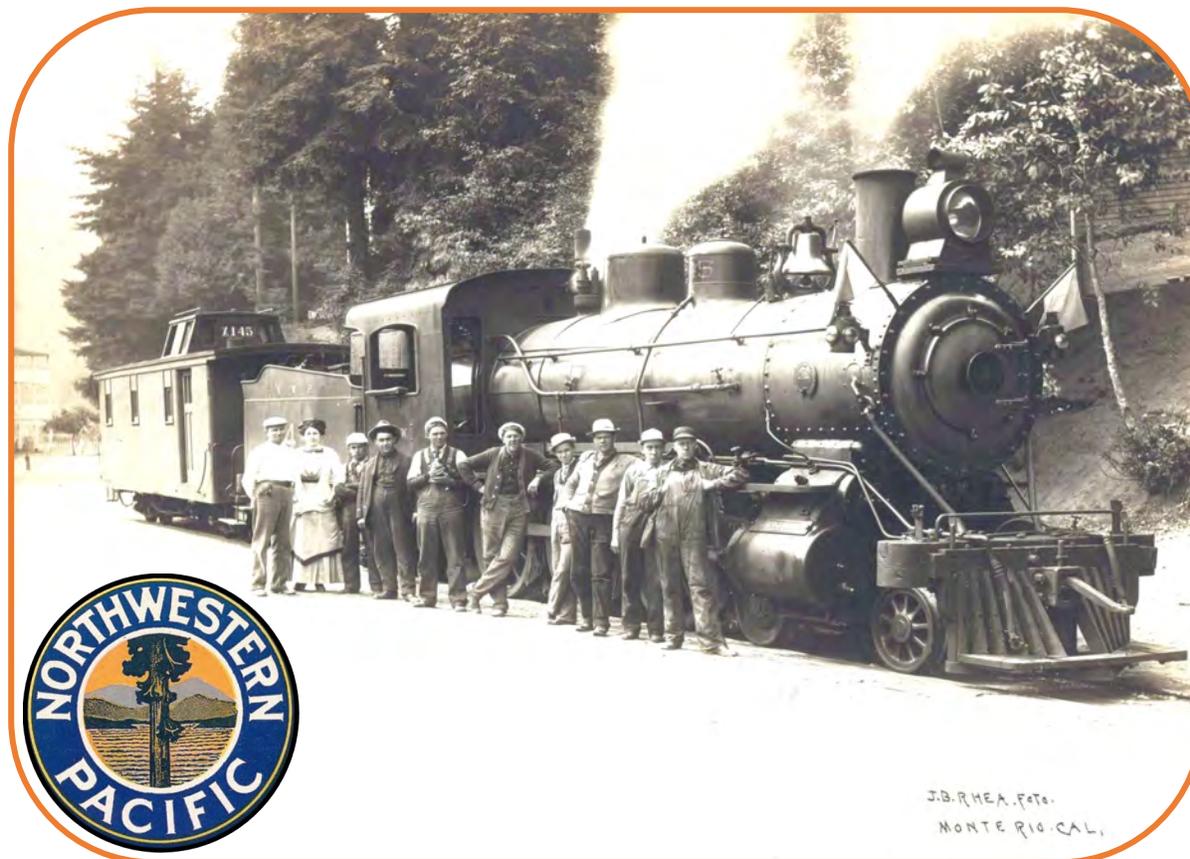
Northwestern Pacific Railroad “Ten-Wheeler” locomotive No. 145 with NWP caboose No. 6101, posed with train crew and bystanders at Monte Rio, California, summer 1910. J. B. Rhea, photographer. Courtesy of NWPRRH Archive, Raymond J. Roix Collection.

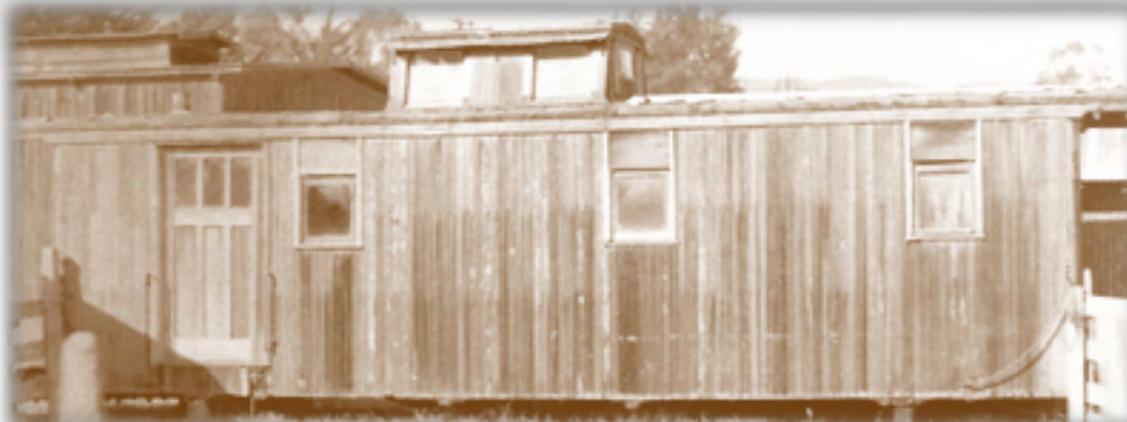
The former Northwestern Pacific Railroad caboose No. 5591, nee-6101, enduring the elements and passing decades as a privately-owned cabin and storage shed at Point Reyes Station, California circa 1950. Courtesy of Jack Muzio.

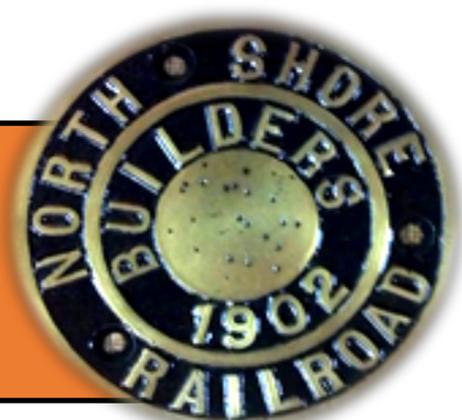
California State Railroad Museum, Frank Saarni Collection.

A kingpin cover plate cast in brass by or for the North Shore Railroad in 1902 for use in one of the road's electric motor suburban cars built in the Sausalito Shop. Two replicated plates might also be considered as worthy additions to Northwestern Pacific Railroad caboose No. 6101 if it can be proven to have been built or finished by the North Shore in the same general time period.

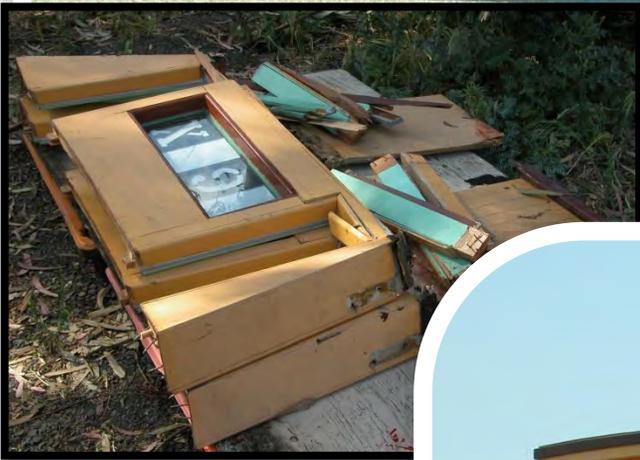
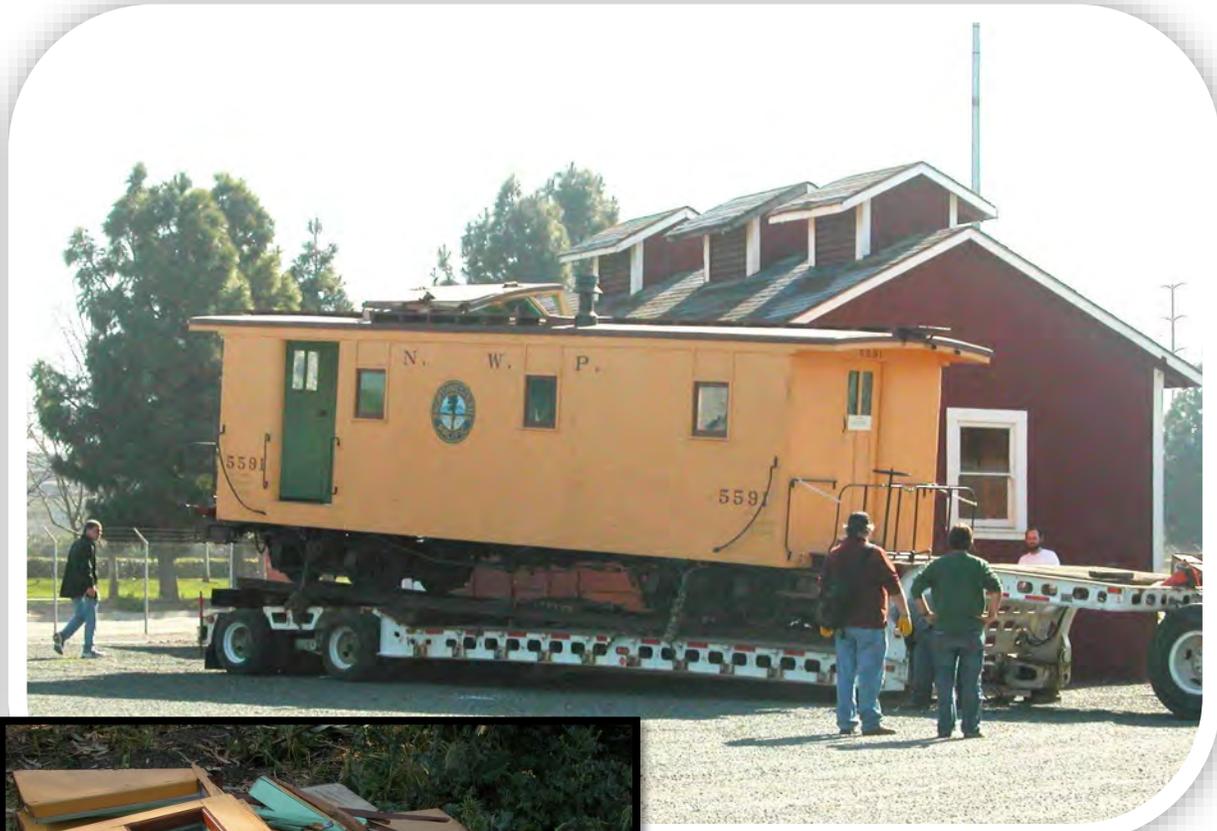
“A funny thing happened on the way to the Forum . . . or, more accurately, on the way to the Patterson Ranch. The truck rig hauling the caboose from West Sacramento took an unauthorized detour and passed beneath a restrictive overpass, the cupola taking the hit, literally and fully. Fortunately, the mostly replica assemblage had been fastened with wire nails (rather than wood screws and lag bolts). The cupola surrendered surprisingly neatly, or so it was found after the off-loading at the ranch was finished. The cupola was then repaired at a subsequent Rail Fair as part of a hands-on demonstration of vintage car repairs.
